# Manhole Inspection Summary

Manhole # S41MM\_003MH

Insp Date: **3/27/07 10:38 AM**

**Location** Address: **2101 HOLY CROSS LN**

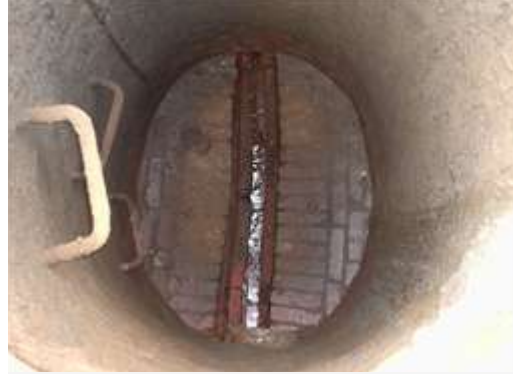
Top View

Corroded steps. Evidence of surcharge - Bench debris.

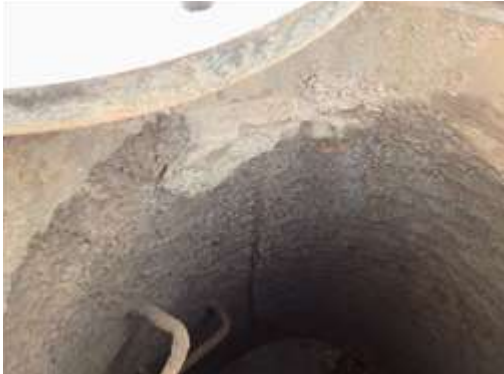
Defect

Frame leaks. Frame offset. Adjustment deterioration and infiltration. Corbel infiltration.

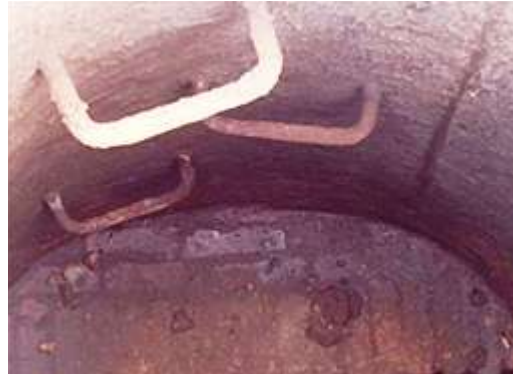
Defect

Corroded steps. Bench debris. Barrel infiltration.

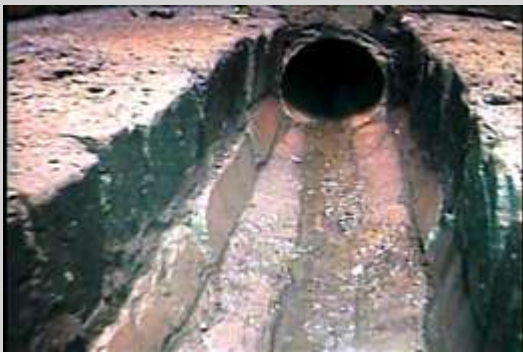
### 6 in. Circular Gravity Sewer Pipe Out @ 12 O'Clock

Channel deterioration.

Infiltration: **Evidence** Pipe Seal Cond: **Broken**

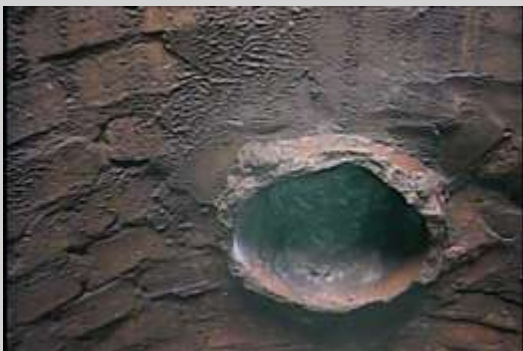
### 8 in. Circular Gravity Sewer Pipe In @ 7 O'Clock

Broken pipe.

Infiltration: **Evidence** Pipe Seal Cond: **Broken**

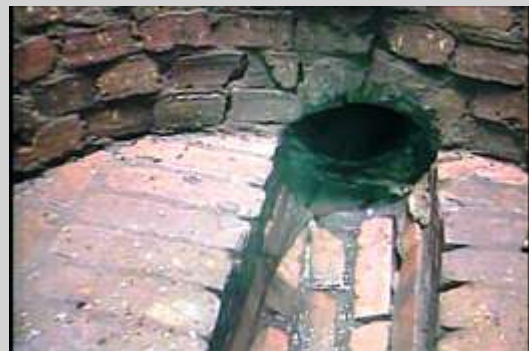
### Drop In @ 7 O'Clock

Barrel deterioration and infiltration. Channel deterioration.
